Technical Bulletin (TB-IJ-14)

Subject: Notches and Damage to Flanges of IB I-joists

May 2014 (Updated June 2017)

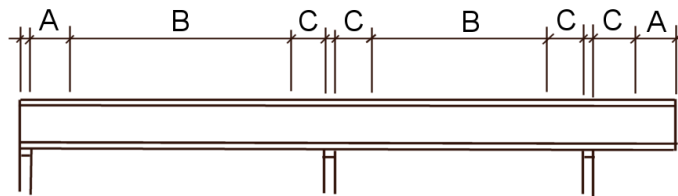
Key to Damage Locations
(not to scale)

- 1) See details for slight damage permitted at locations A and B. Dimension A shall be less than or equal to the joist depth. Dimension C shall be greater than or equal to the joist depth. Damage at location C and at bearing locations is beyond the scope of this document.
- 2) Except for corner notches, these details are intended to apply only to damage at the top flange.
- 3) Maximum two damages per joist and minimum 24" between damaged locations.

Any damage condition that exceeds the limits indicated above requires an engineering analysis.
